Inverness Water and Wastewater Assessment

PRESENTATION FOR MUNICIPAL COUNCIL

Dillon was contracted to complete an assessment of existing water and wastewater (W&WW) infrastructure within the MOCI.

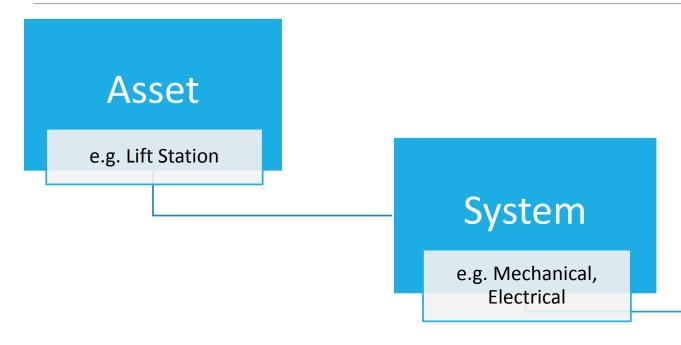
Figure 10 – Asset Hierarchy Example

Element

e.g. Pump, Electrical Panel

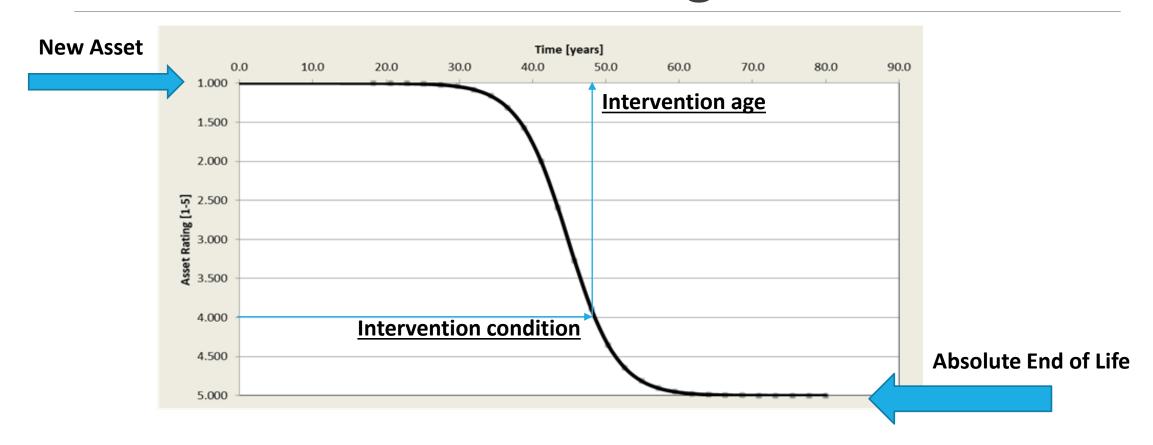
Figure 11 – Deterioration Curve for PVS/DPE Piping for W&WW Applications

How Does an Asset Change Over Time?

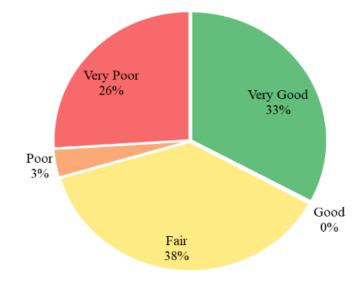
Figure 12 – All Communities, All Linear Assets

- General condition of linear infrastructure is "fair" (middle scale)
 - Watermains generally in Worse condition
 - Forcemains generally Fair or Very Good condition
