## JUDIQUE DAM

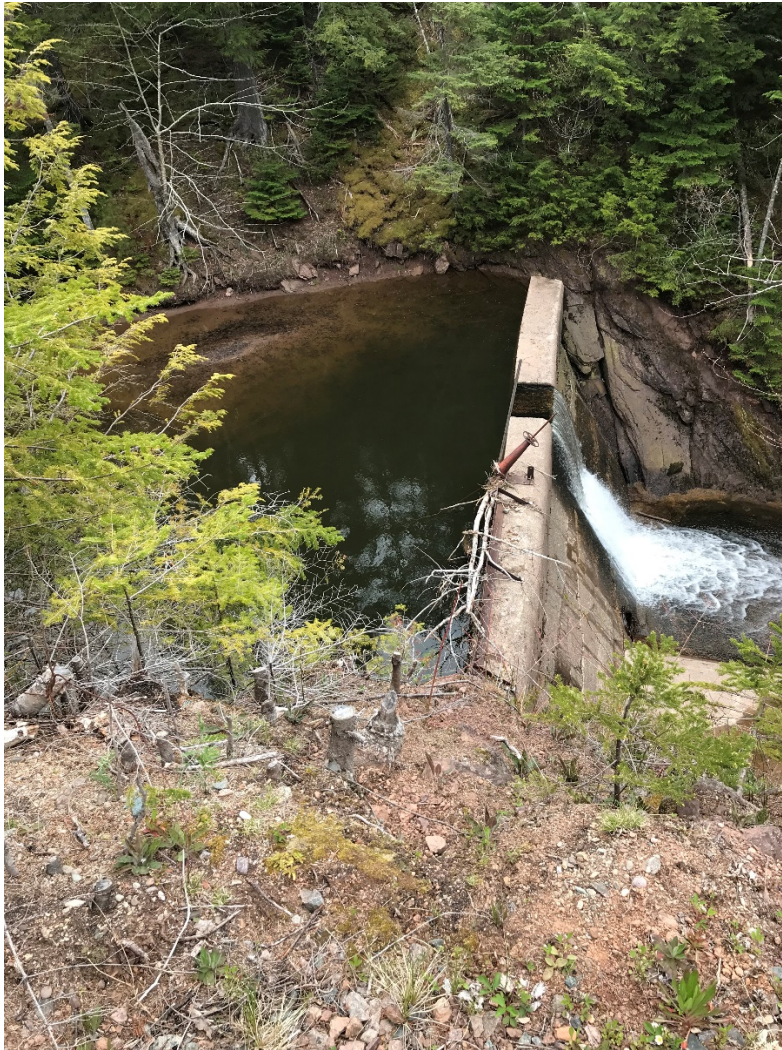
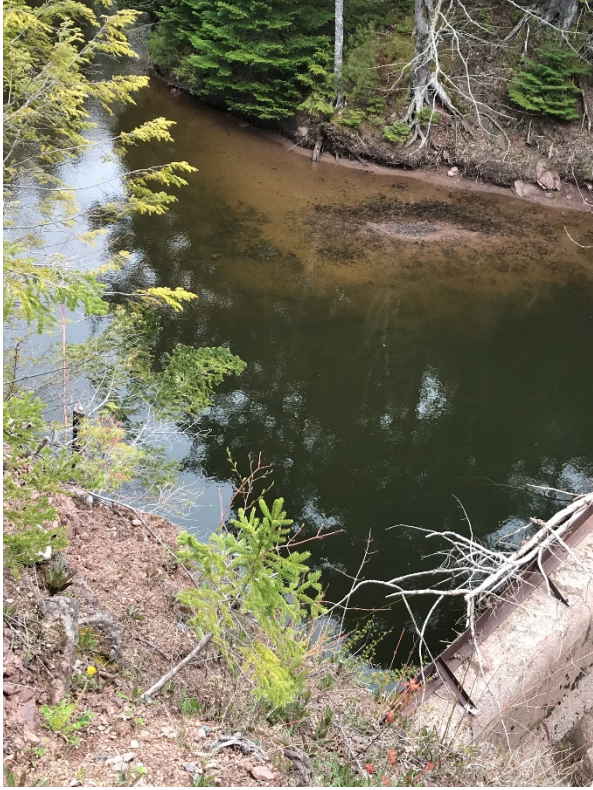
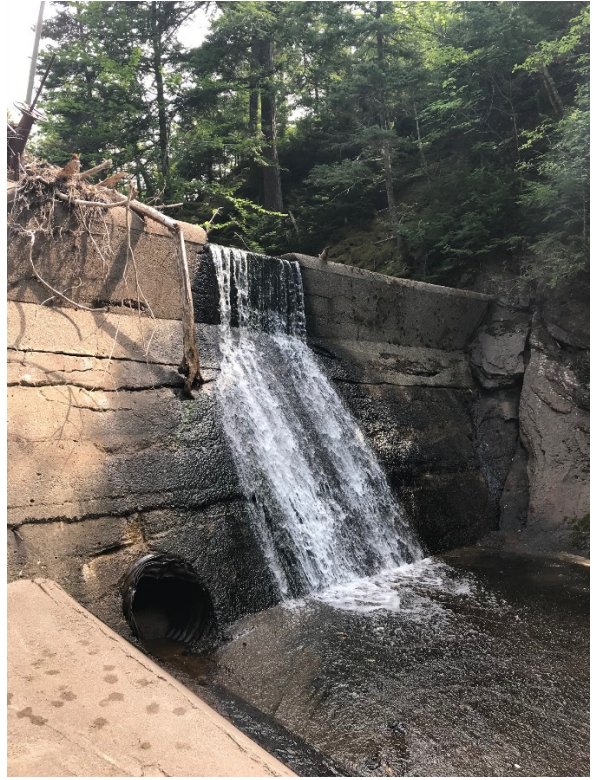
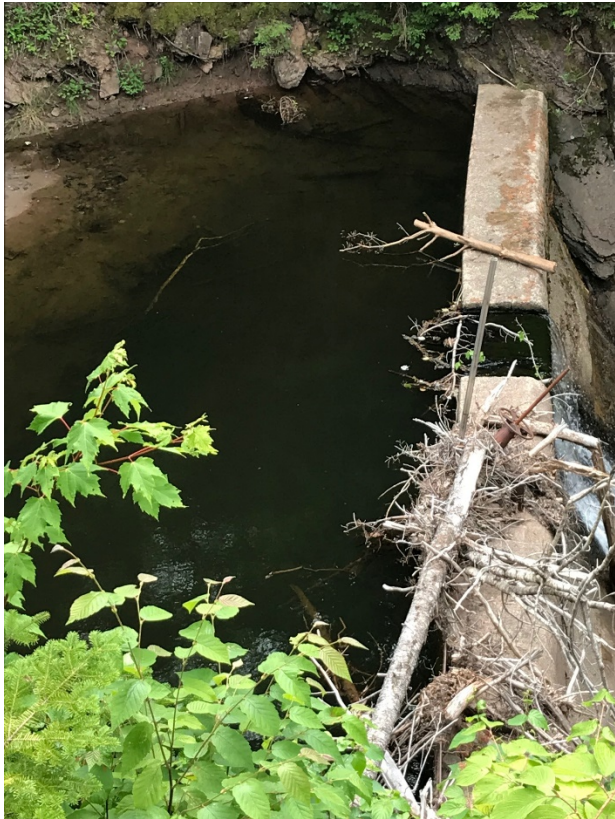
- Drain Valve is broken and needs to be repaired at the bottom.
- There is a build-up of silt and debris at the bottom of the dam, and we have been unable to alleviate this due to the drain valve being broken.
- Work had been done in the summer of 2013 to repair the inlet piping and install a concrete shield to protect the piping at the dam.
- The dam is 10m wide by 3m high and was constructed in 1973 (by Zutphen Bros if I read the tender document correctly). I can not find any other specs on the dam.
